Subject: Boeing Submission - Egyptair 767-300ER SU-GAP, Accident off

Nantucket, Massachusetts - 31 October 1999

# Submission to the National Transportation Safety Board for the

# Egyptair 990 Investigation

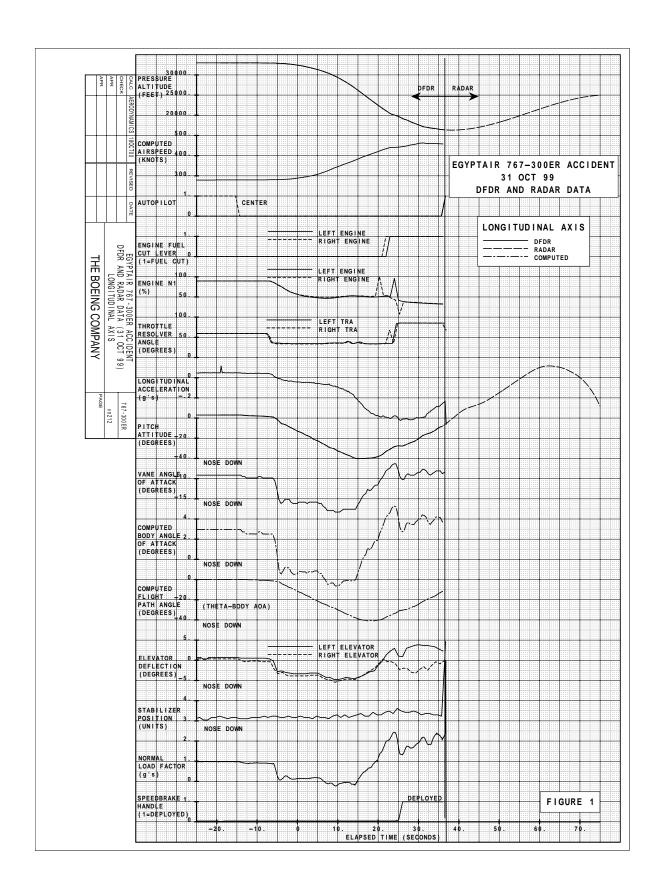
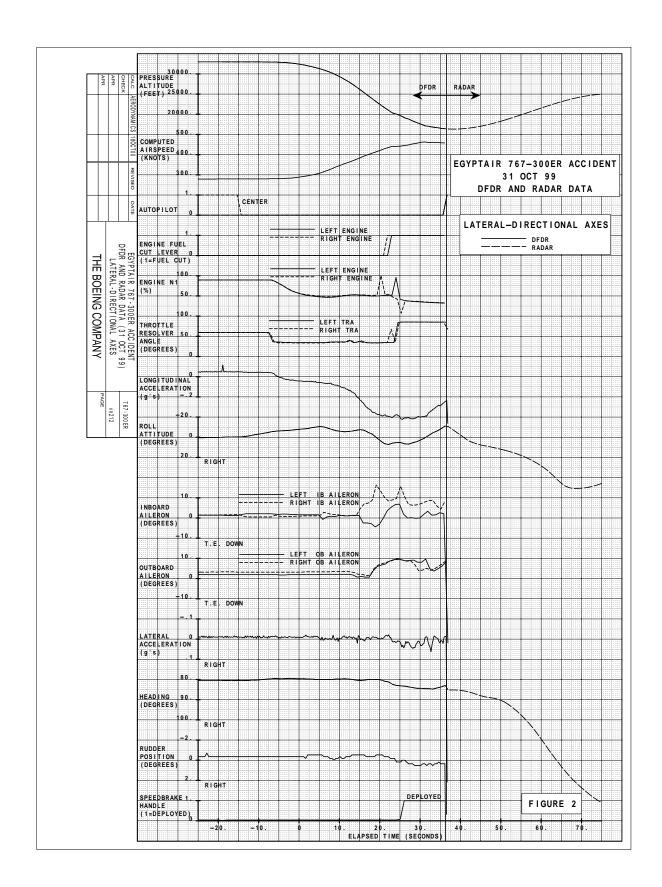
Beyond an ET of 37 seconds, the data presented on these figures are based on primary radar returns. These computed pitch, roll, and heading angles and the pressure altitude are provided by the NTSB. These calculations indicate that the airplane recovered from the dive at about 16,000 feet and then climbed back to about 24,000 or 25,000 feet. During this climb, the NTSB derivation indicates that the airplane turned 60 degrees to the right, reaching a magnetic heading of about 140 degrees. The derivation of airplane motion and altitude from radar data was terminated at an ET of 75 seconds. Beyond an ET of 75 seconds, the airplane entered a second dive that continued until impact with the ocean at an ET of approximately 150 seconds. This second dive occurred at much lower altitudes, where fewer radar returns were recorded. As a result, estimates of the airplane's altitude profile and performance were not performed.
